Bogue Brook Reservoir Dam Rehabilitation

BOGUE BROOK DAM

INSPECTION REPORT

INSPECTION CONDUCTED JULY 18, 2016

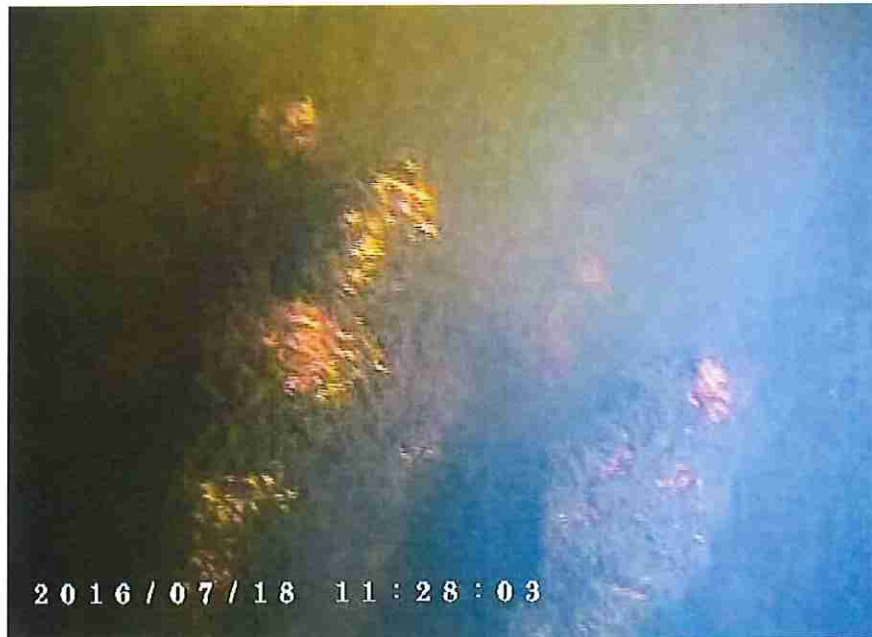
Immediately inside the end of the 16" pipe 5 small pipes surround a slightly larger pipe in the center. This group of pipes extend slightly past the end of the 16" pipe. The purpose of these pipes is unknown.

6 smaller diameter pipes inside 16" LLO pipe

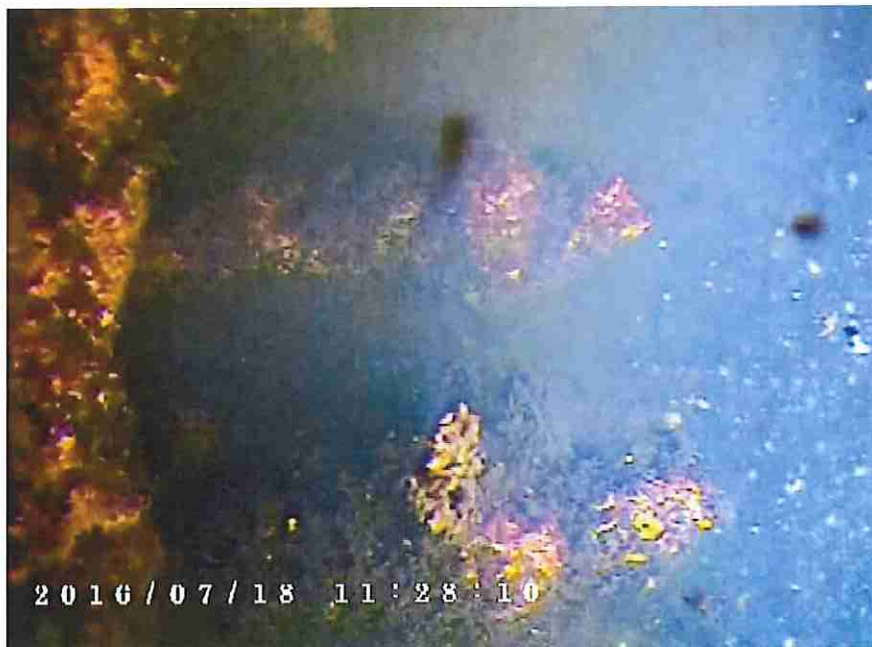
Side view of pipes within the LLO pipe

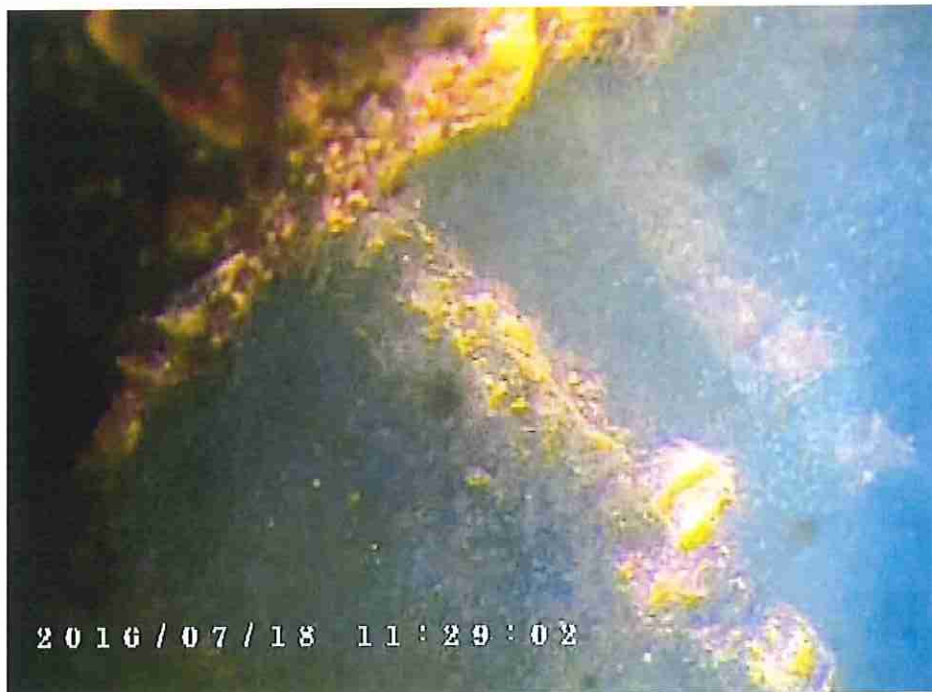
Pipes within LLO

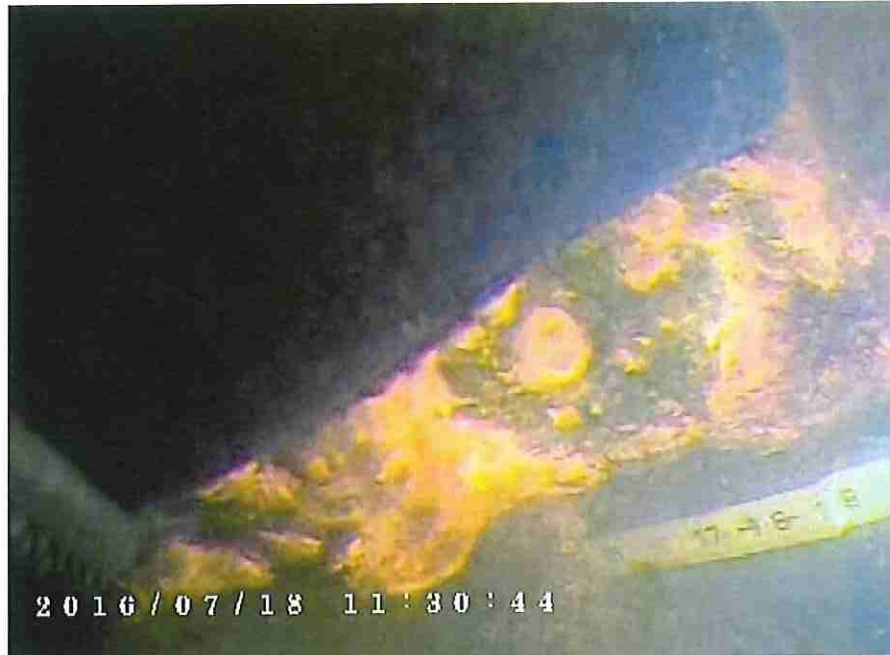
In the center of the dam a rectangular box structure 15' wide by 4' high extends upstream 6'. 42" below the top of the box is the crown of a 16" ID iron pipe. The pipe ends with a bell section 9' upstream from the face of the concrete box. When probed there was 3' of sediment over consistent hard refusal thought to be a localized concrete slab.

Measurement of LLO pipe

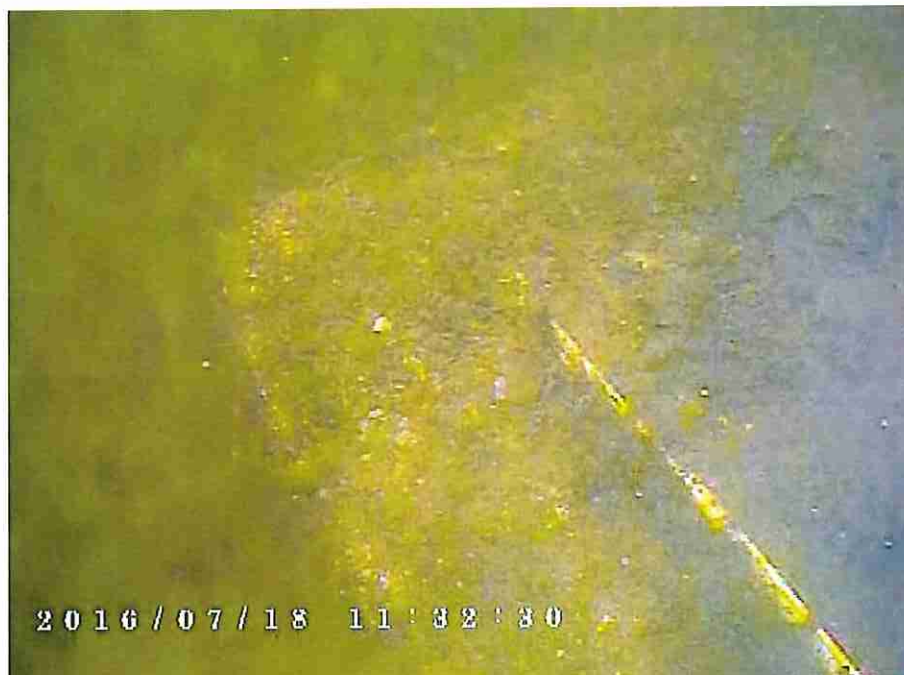
Rectangular box at toe of dam where LLO pipe extends

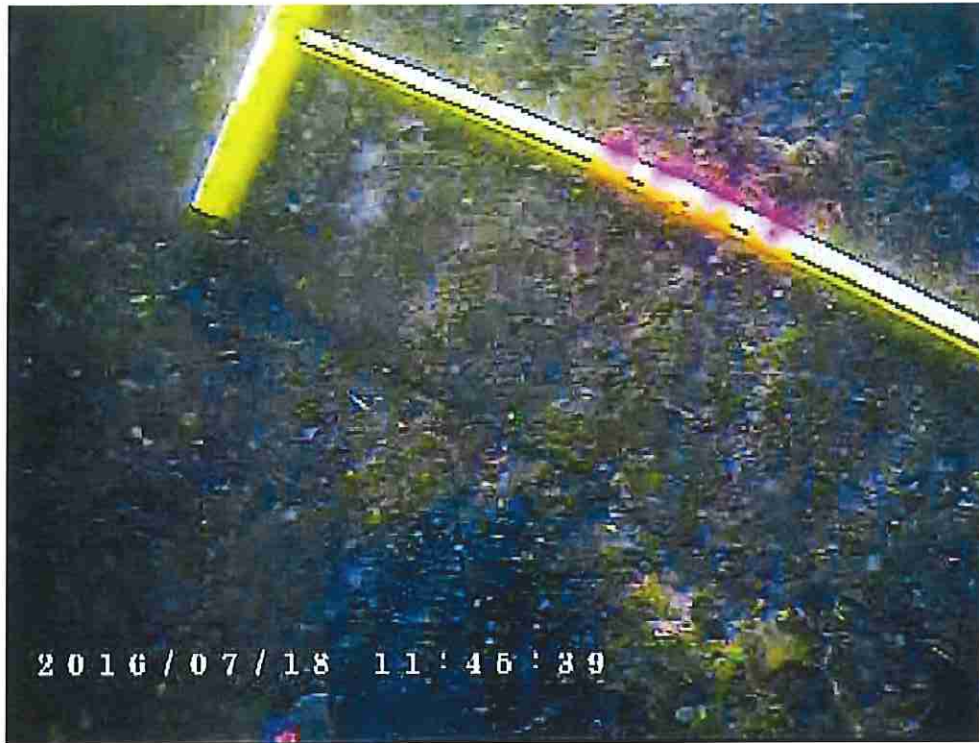
Two spall areas were identified one each on the left and right. Both are contained on a control joint and show signs of a prior patch attempt. The spall on the right measured 3" wide by 2" deep running horizontal 3' below the water surface for a distance of 10'. The left spall measured 5" wide by 5" high and 3" deep. It is located approximately 25' from shore. Reinforcing steel was not visible on either.

Spall at control joint approximately 3' below water surface

- 1) Repair compromised spall areas. Utilizing an approved underwater applied mortar product. Application should be done by a qualified and experienced contractor proficient in this type of work.
- 2) Conduct routine inspections to identify potential problems and ensure dam safety.

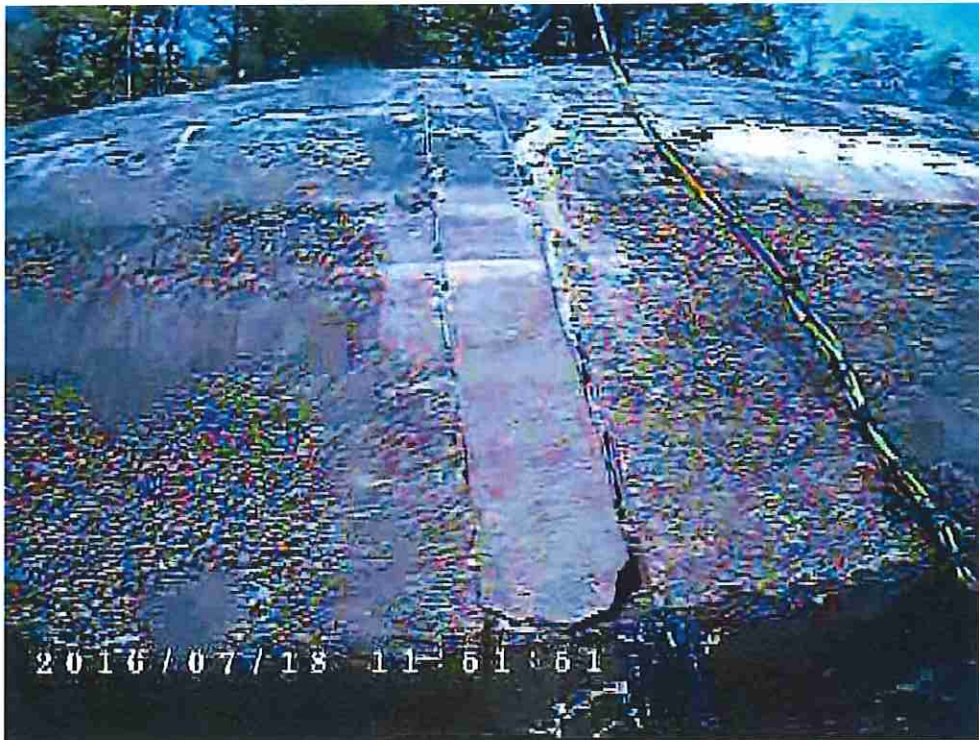
Spalling at prior patch
